**Third Five-Year Review Report
for**

**Allied Plating, Inc
Superfund Site
Portland, Oregon**

September 2008

Prepared by EPA Region 10, Seattle, Washington

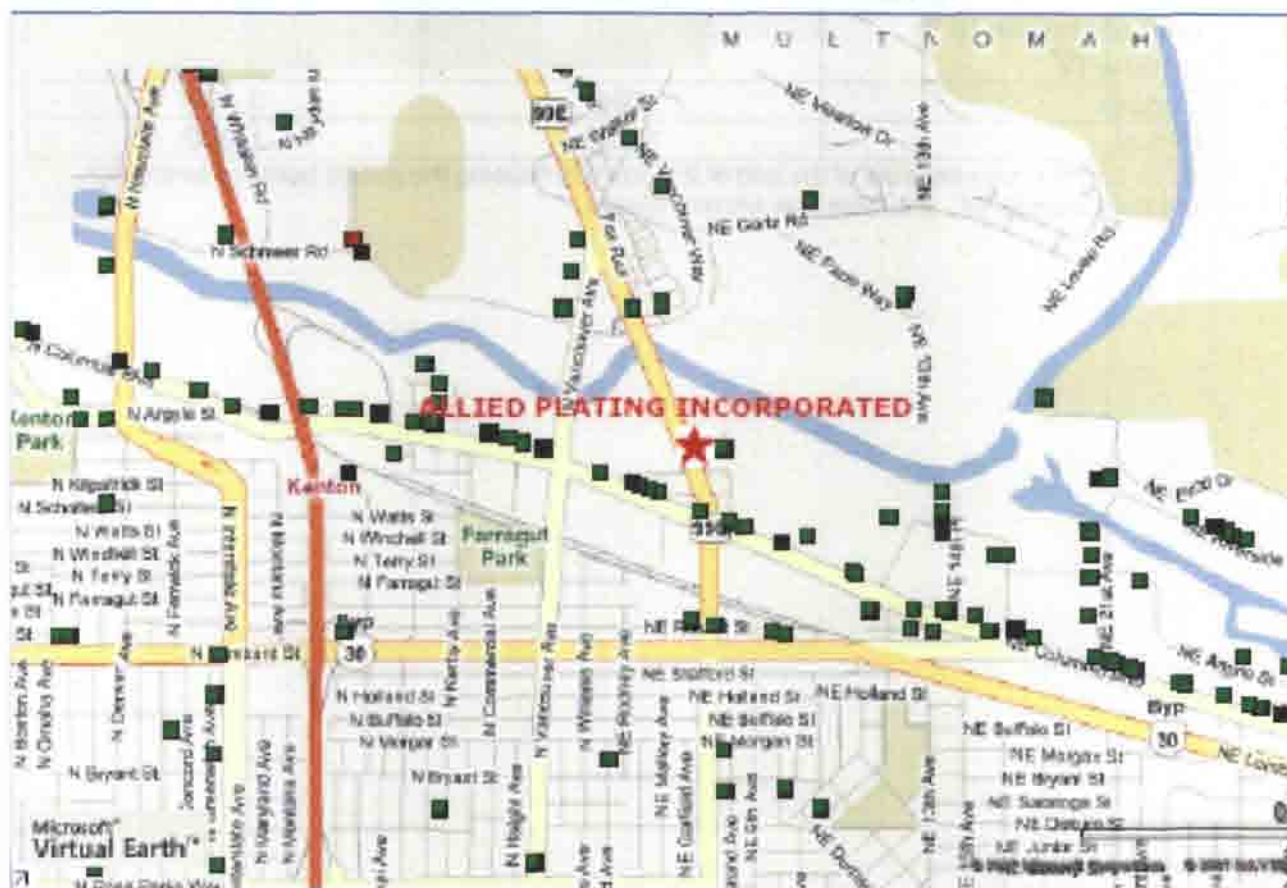
aquifer, the extent of the restriction was appropriately limited to the former Impoundment Area on the Site (Tracts H&L in Figure 3).

In 2008 a Title Search was conducted by an EPA contractor which confirmed that the Deed Restriction recorded in May, 1993 was recorded properly and remains on the property records. A copy of the Title Search is attached to this review. The search report identified two prior encumbrances (one for power poles/maintenance and the other for streets), but neither is such that they would compromise the functioning of this Institutional Control or the remedy. EPA also confirmed that the property and surrounding properties remain zoned for industrial or commercial use, consistent with the cleanup goals used to guide the removal action. Given the post-removal risk assessment results and elimination of the MCL for nickel in 1995 there is some question whether any restriction on use of the site remains necessary. See Figure 2 for a detail photo with site features and Figure 3 for property and institutional control boundaries from the title search.

Property and Institutional Control Boundary
